DEPARTMENT OF TRANSPORTATION

Contract #: 04-0120F4Cty: SF/ALA Rte: 80 PM: 13.2/13.9File #: 1.28**WELDING INSPECTION REPORT****Resident Engineer:** Casey, William**Address:** 333 Burma Road**City:** Oakland, CA 94607**Report No:** WIR-028755**Date Inspected:** 14-Nov-2012**Project Name:** SAS Superstructure**OSM Arrival Time:** 700**Prime Contractor:** American Bridge/Fluor Enterprises, a JV**OSM Departure Time:** 1730**Contractor:** American Bridge/Fluor Enterprises, a JV**Location:** Job Site**CWI Name:** See below.**CWI Present:** Yes No**Inspected CWI report:** Yes No N/A**Rod Oven in Use:** Yes No N/A**Electrode to specification:** Yes No N/A**Weld Procedures Followed:** Yes No N/A**Qualified Welders:** Yes No N/A**Verified Joint Fit-up:** Yes No N/A**Approved Drawings:** Yes No N/A**Approved WPS:** Yes No N/A**Delayed / Cancelled:** Yes No N/A**Bridge No:** 34-0006**Component:** OBG**Summary of Items Observed:**

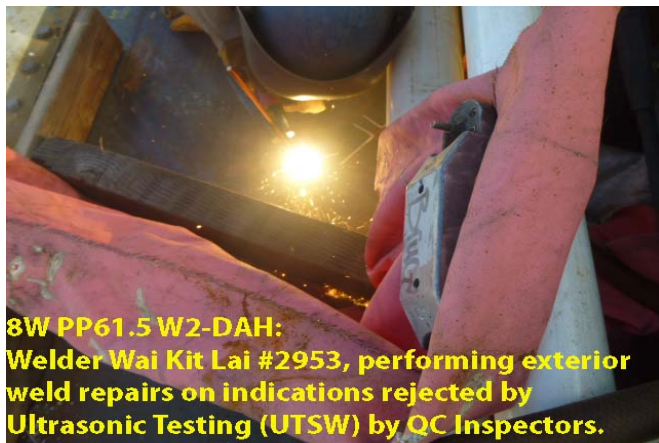
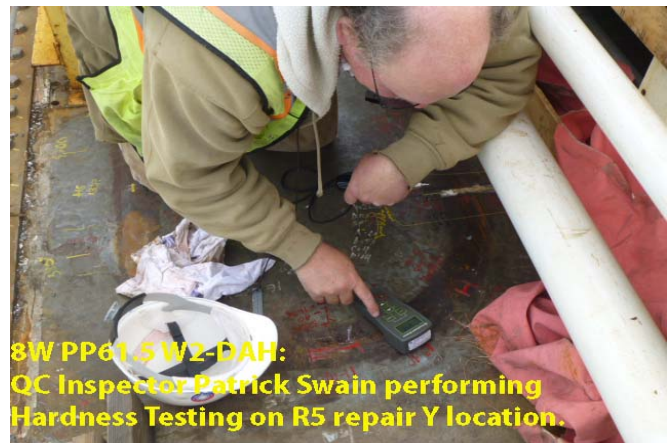
Welder was observed performing exterior weld repairs on weld 8W PP61.5 W2-DAH on indications rejected with Ultrasonic Testing (UTSW) by QC Inspectors. Welder was observed utilizing Welding Procedure Specification (WPS) ABF-WPS-D15-1004 Repair for Shielded Metal Arc Welding (SMAW). Welding parameters as verified by QC Inspector Barry Drake appear to be in compliance with the WPS noted above. Weld noted above is non SPCM and "Request for Weld Repair" (RWR) is not required for R1 and R2 repairs.

Weld 8W PP61.5 W2-DAH:

- Face A Excavation 110 x 20 x 13 Deep at Y 710.
- Face A Excavation 230 x 30 x 13 Deep at Y 1620 + 1735
- Face A Excavation 190 x 30 x 13 Deep at Y 2410 + 2490
- Face A Excavation 80 x 20 x 6 Deep at Y 2995

- Face A Excavation 170 x 20 x 13 Deep at Y 3140
